Addendum Geotechnical Report, Wood Trails,
August 2005

**PREPARED FOR
PHOENIX DEVELOPMENT, INC.**

**ADDENDUM GEOTECHNICAL
REPORT
WOODTRAILS
WOODINVILLE, WASHINGTON**

ES-0067

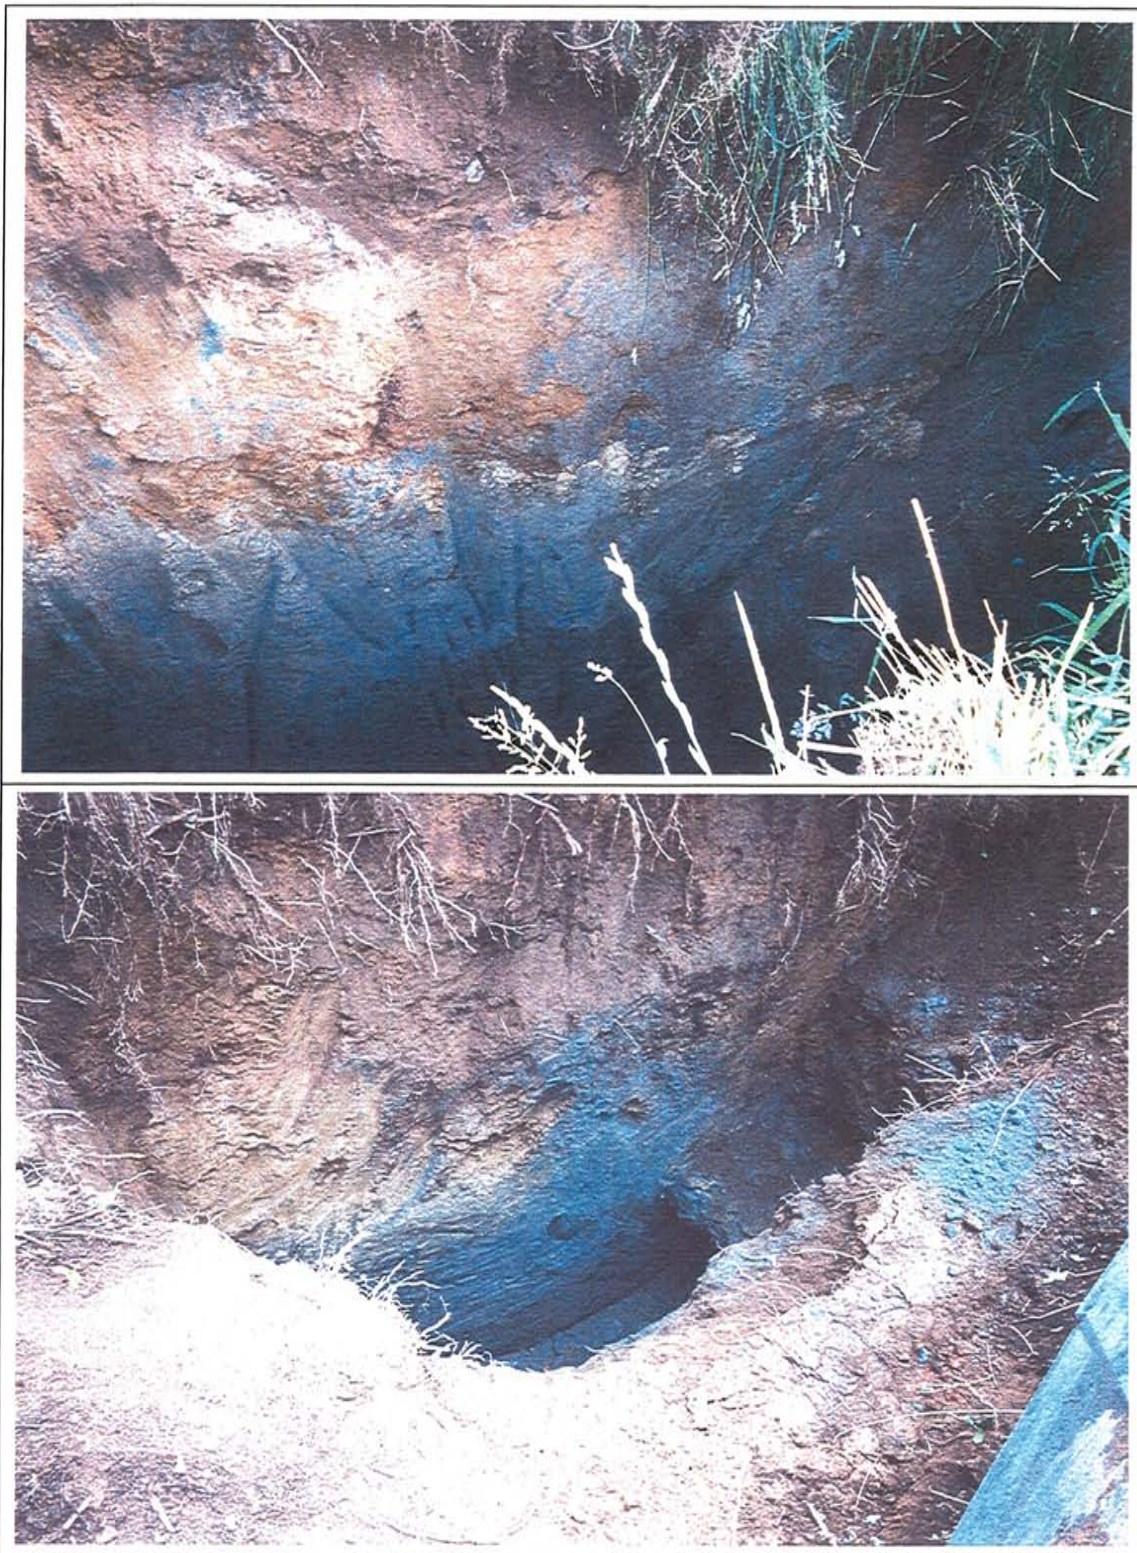
Job No. ES-0067
Plate 3

Woodtrails - Supplemental test pits in detention pond. Dense to very dense Silt and Silt with Gravel. Excavated to 20 feet.

Throughout the lower regions of the Wood Trails site, in the vicinity of the proposed storm water detention pond, loose to medium dense silty sand with gravel mantling dense to very dense sandy silt and sandy silt with gravel was predominantly encountered at the test sites (USCS Designations SM and ML, respectively). The silty sand with gravel deposit typically extends to a depth of six to eight feet before transitioning into the underlying dense to very dense sandy silt and sandy silt with gravel. The sandy silt was generally massive and contained varying amounts of gravel and occasional cobbles. At one of the test sites, a two foot by four foot boulder (erratic) was encountered at a depth of approximately eight feet.

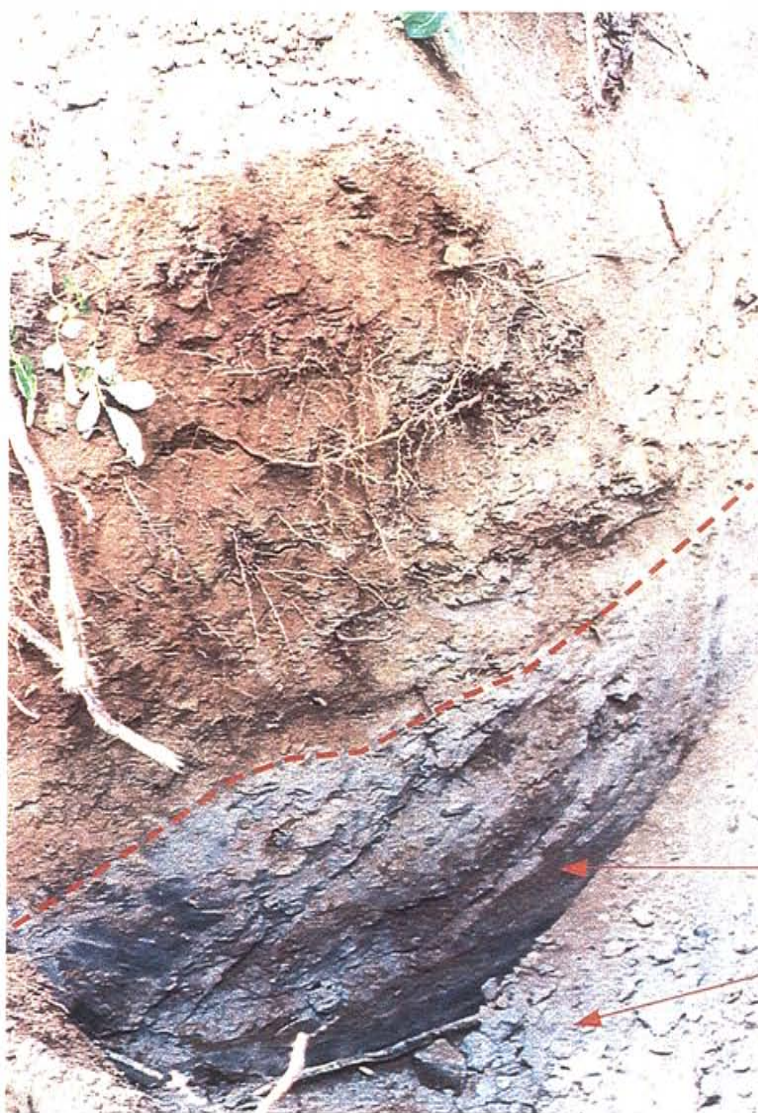
Photo 1: Test Pit TP-301

Loose, Weathered Glacial Till

Medium Dense to Very
Dense, Well Cemented
Glacial Till

Chunks of
Cemented Till

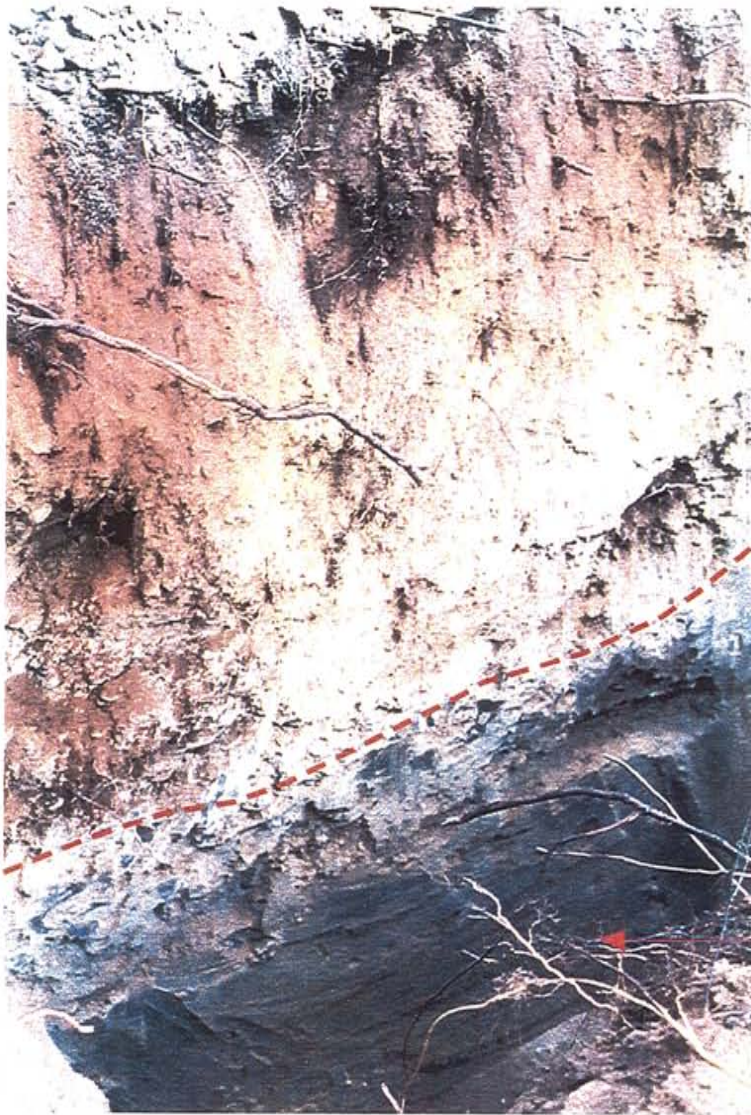
Photo 2: Test Pit TP-303

Loose, Weathered
Glacial Till

Dense to Very Dense
Well Cemented
Glacial Till

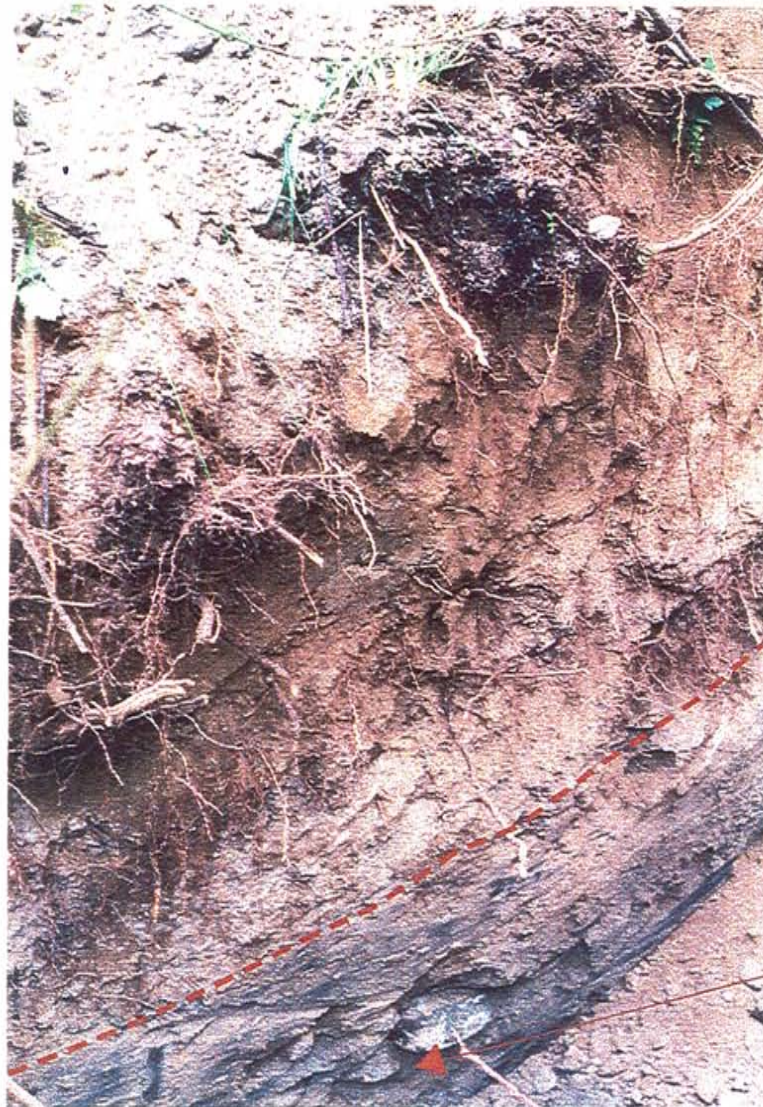
Photo 4: Test Pit TP-306

Loose to Medium Dense,
Weathered Glacial Till

Very Dense, Well
Cemented Glacial Till

Stable Cut in Till
(No Caving)
